Report 2232

MICRO-MARKER PARTICIPATION IN J-LOTS

U.S. ARMY MOBILITY EQUIPMENT  
RESEARCH AND DEVELOPMENT COMMAND  
FORT BELVOIR, VIRGINIA

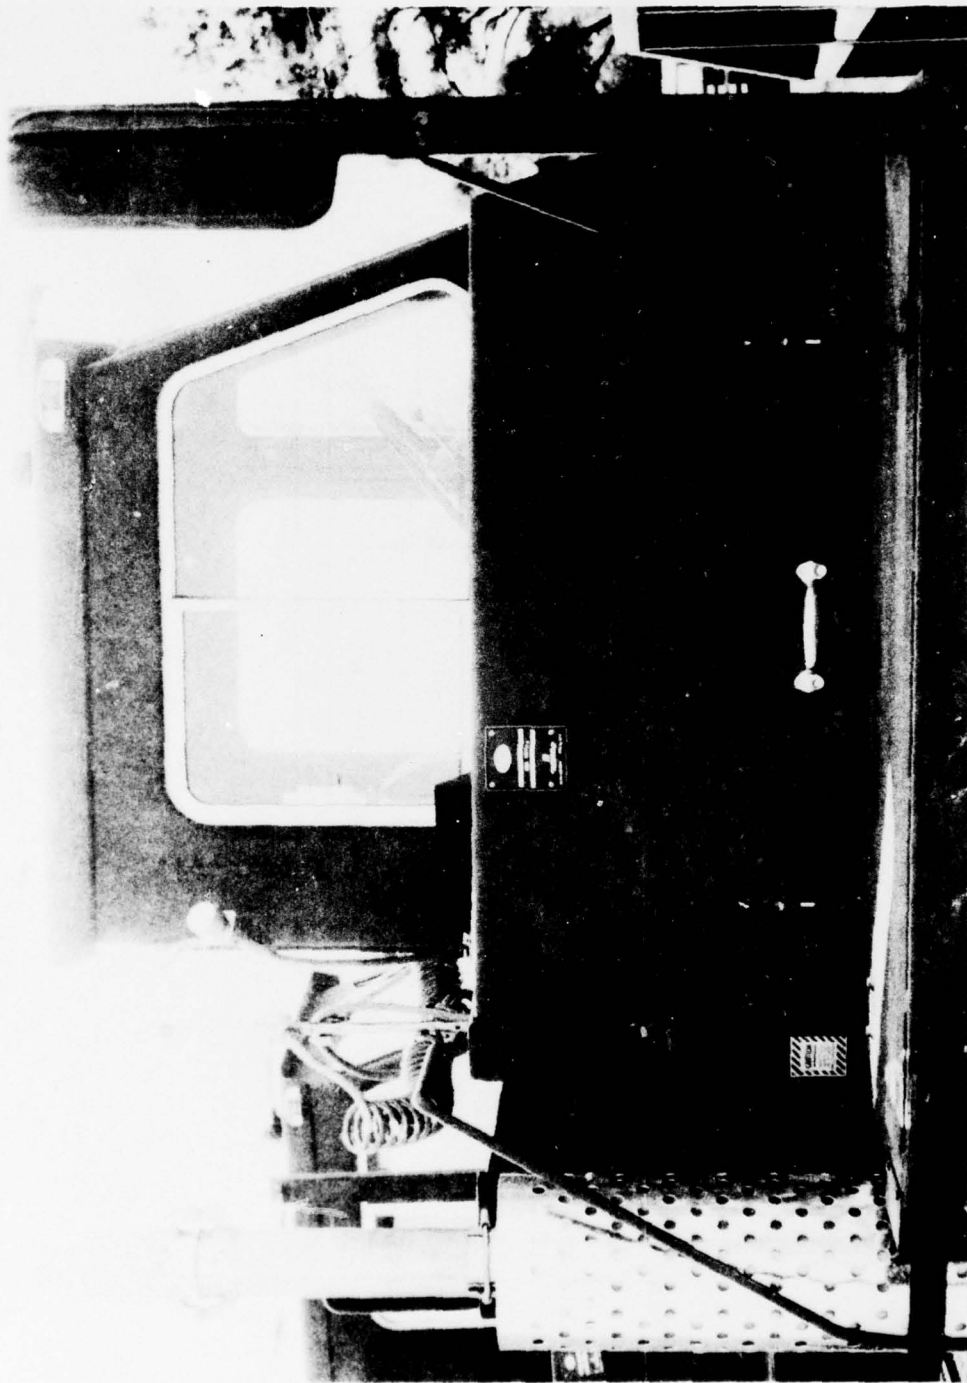
Figure 2. MICRO-Marker Label.

a. **Labels.** MICRO-Marker labels are microwave transponders which are completely passive until activated by an interrogator. When activated, the label transmits a serial number, which is used to identify the container or truck to which the label has been attached (Figure 2).

The labels used were fabricated specifically for the J-LOTS exercise. The label design used was similar in physical construction to the earliest exploratory development models but incorporated the functional electronic improvements achieved in the latest advanced development models. The labels consisted of a microwave section and a digital section assembled into a 4- by 5- by 1/2-inch aluminum housing and potted in place. The microwave section was a sandwich of metal-clad plastic plates etched to form strip-line antennas and filters. The digital section was a conventional printed circuit board populated with separately packaged integrated circuits.
